Town of Palisade, Colorado

Draft Environmental Assessment for the Palisade Sewer Transfer Conveyance Line Project

Per USDA Rural Development Requirements

J-U-B ENGINEERS, INC.

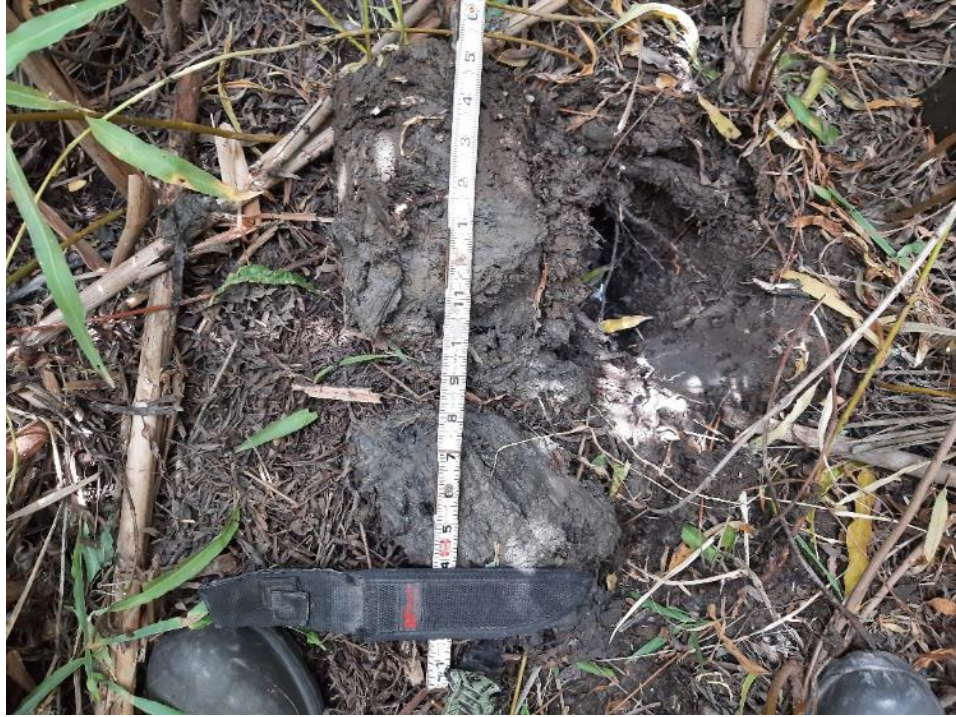
SP01 Typical Site Conditions | Soils

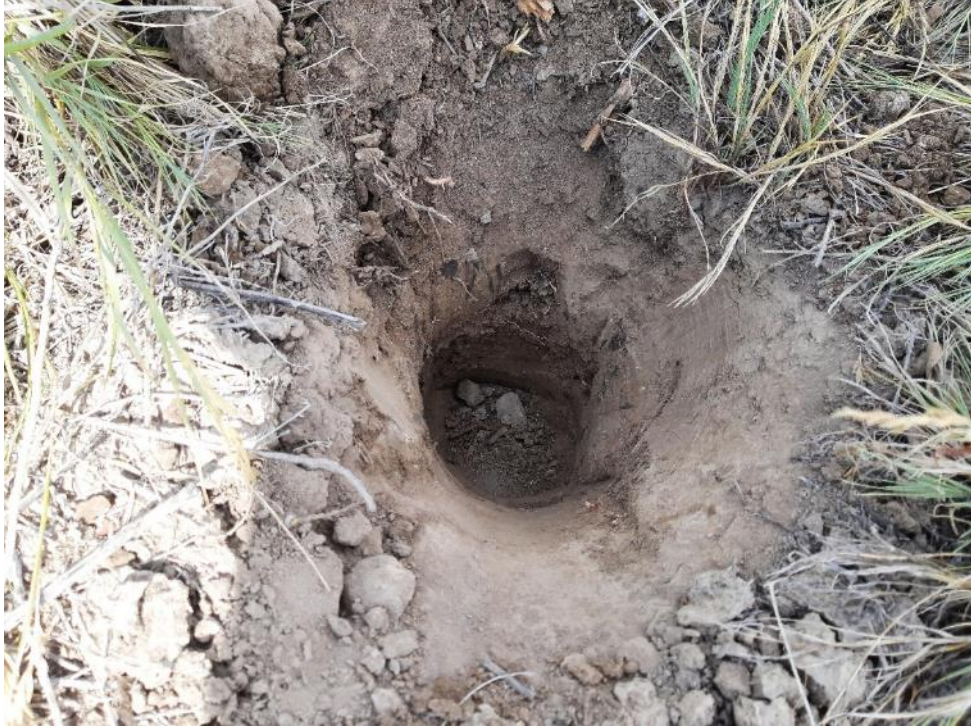
SP02 Typical Site Conditions | Solis

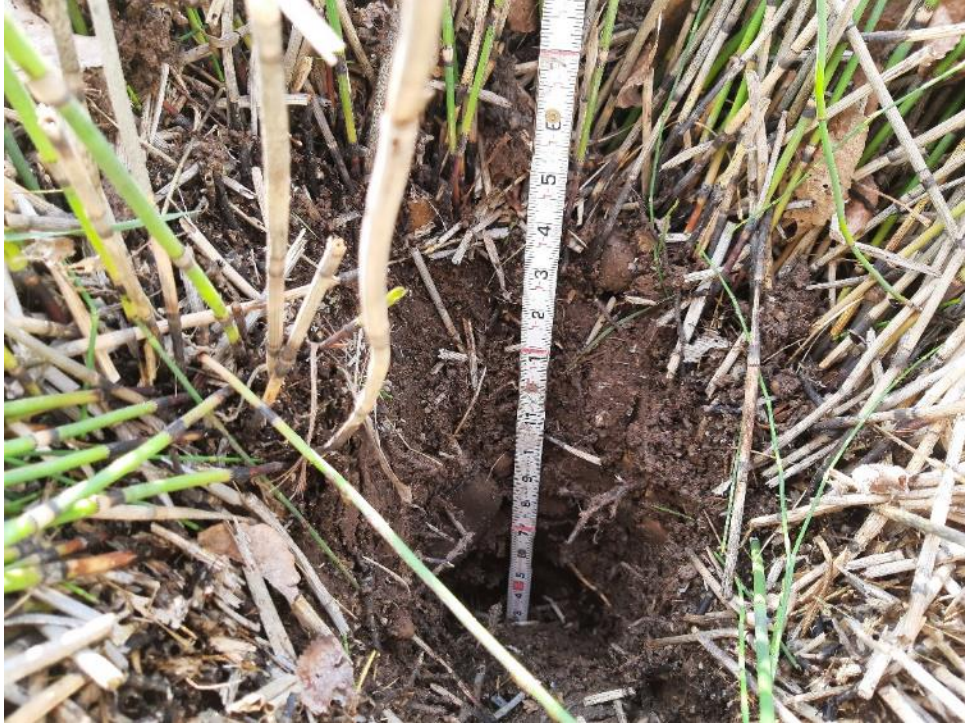
SP03 Typical Site Conditions | Soil

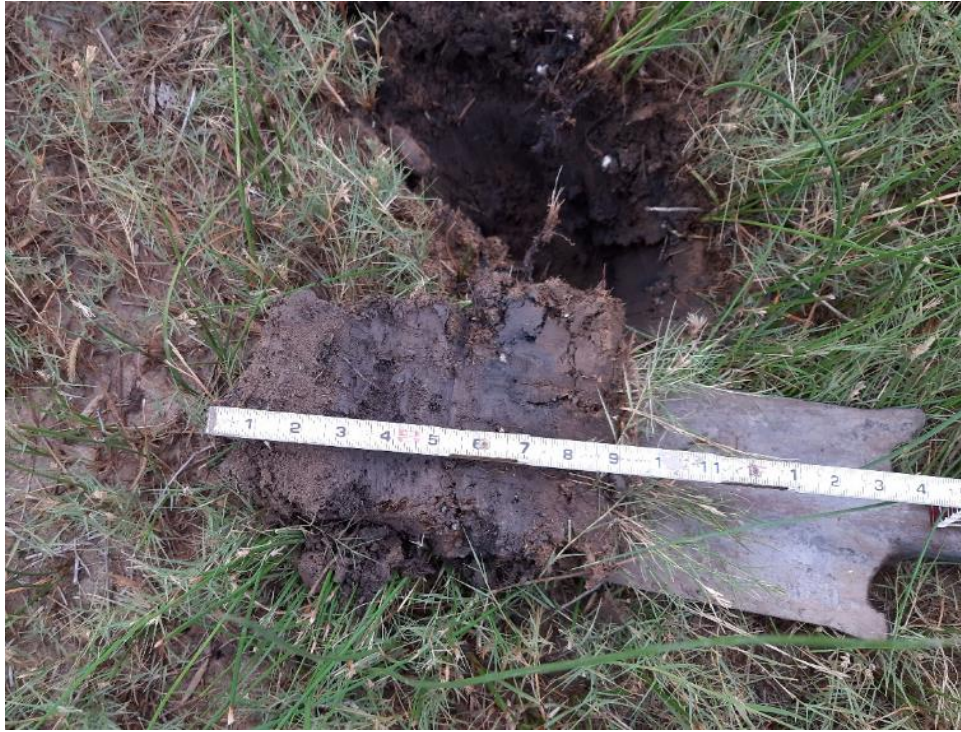
SP04 Typical Site Conditions | Soil
